SIO Shipyard Representative Bi-Weekly Progress Report		
Project: AGOR 28	Contract No.: N00014-12-C-0305	Shipyard: Dakota Creek Industries
Prepared by: Paul D. Bueren Scripps Institution of Oceanography (SIO) 297 Rosecrans St. San Diego, CA 98106	Date: 20 November 2015	Program Officer: Robert (Tim) Schnoor Office of Naval Research 875 Randolph St ONR 321 Arlington, VA 22203-1995
Distribution Statement A: Approved for public release; distribution unlimited.		Report No. A002.089

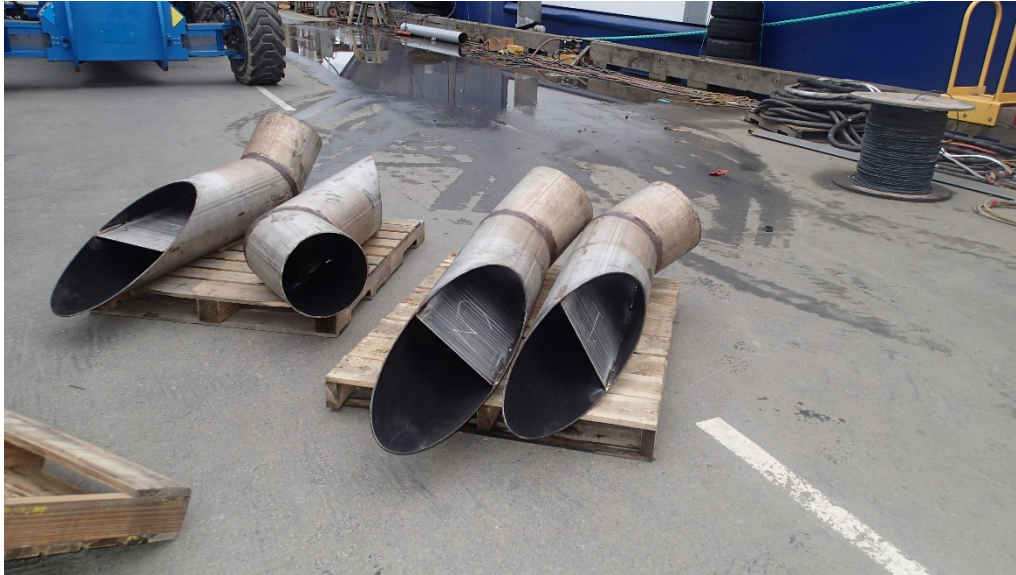
Exhaust Baffles

- **Main Deck Noise Levels** – This week NCE was on site testing the noise levels various exhaust pipe configurations. For each test all four engines were running and shore power was secured. The configurations were as follows:

- As-built
- Baffle in incinerator exhaust pipe only – (preliminary result- noise level decreased)
- Baffles added to all four engine exhaust pipes (preliminary result – no change from previous)
- Engine exhaust pipes removed so that exhaust was vertical and below the coaming of the stack. (preliminary result – noise levels increased)
- Engine exhaust pipes rotated near 90-degrees outboard vice the 45-degrees done on Armstrong. (preliminary result – no significant improvement when compared to Armstrong's current arrangement)

These are my observations. A full report will be provided by NCE. The take-away is that the expected result of a 6-db drop when the exhaust pipes were cut off below the stacks coaming was not achieved.

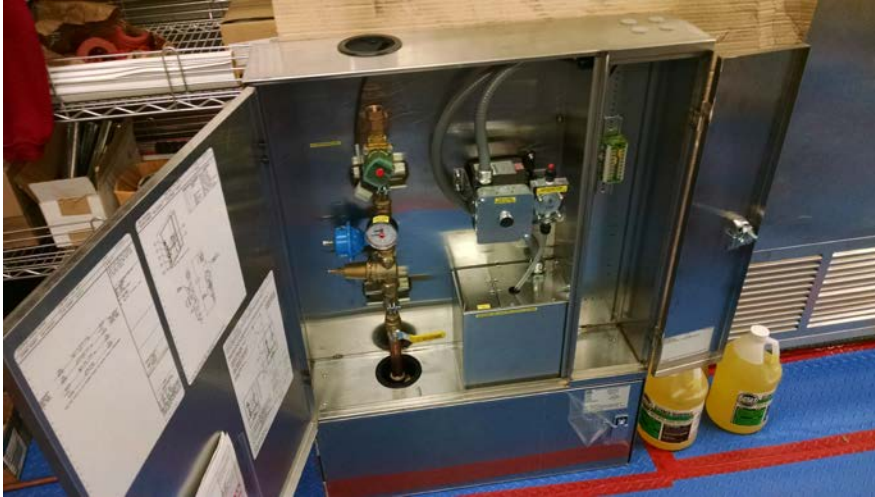
Galley Hood Washdown System Control Cabinet

- Accommodation Spaces – DCI continues with the cleaning and prepping of staterooms for close-outs. The floors are complete in the ADA and Hospital.
- Galley & Mess – Overheads and lighting are being installed in both spaces. The galley exhaust hood washdown system has arrived and the yard is working the installation. The control cabinet is a bit big so some modifications will be necessary.

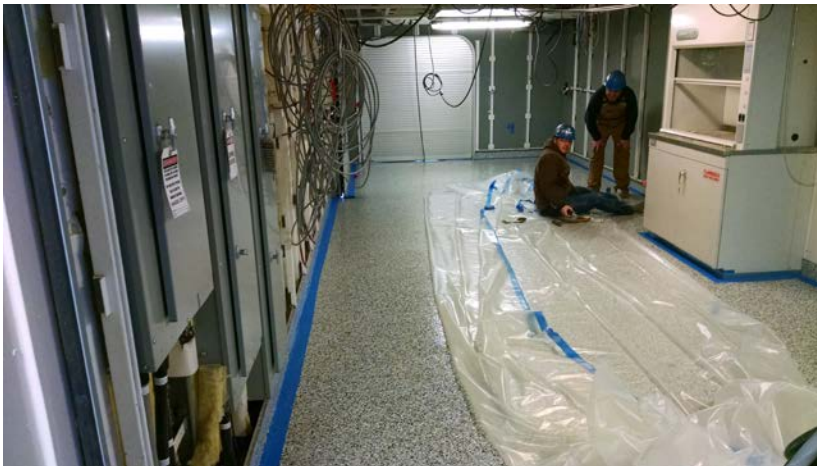
Wet Lab Deck

- Laboratories – The Wet Lab floor has been completed and the flexible material has been poured in the Main Lab, with the final color and sealing coats to be applied next week. Lab overheads, paneling and lighting installation to commence shortly after.

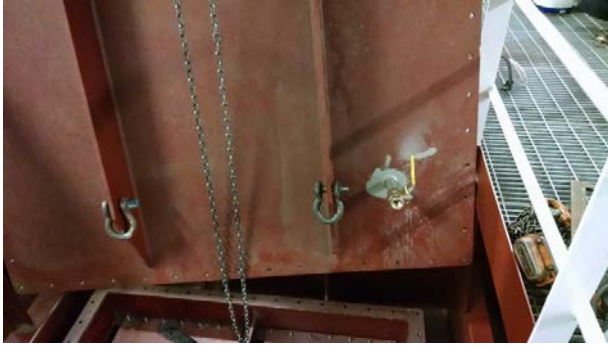
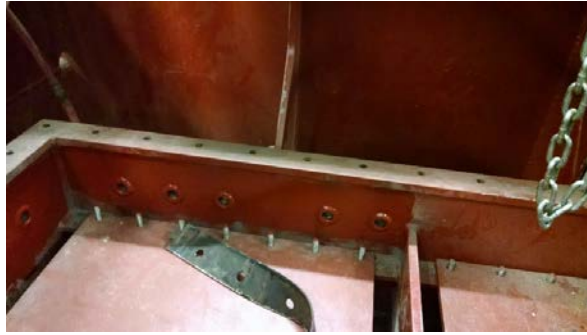
- 3.5kHz Transducer Array- Vent, stuffing tubes and fill line installed.

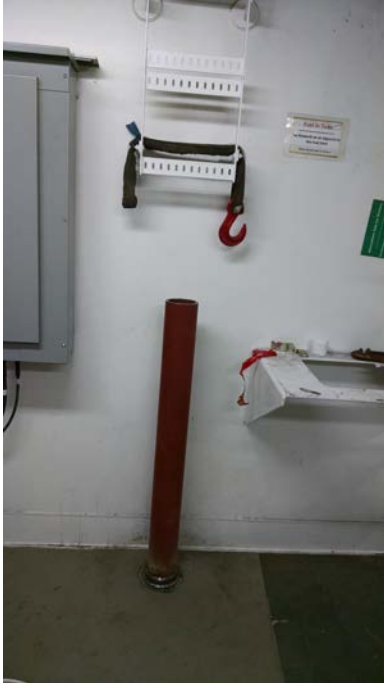
- EK80 – Cable conduit installed between transducer and transceiver rooms.

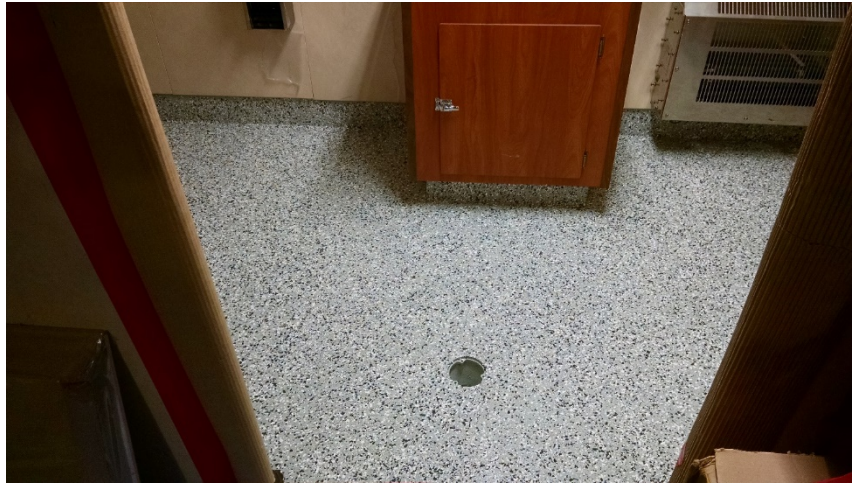
Hospital Head deck.

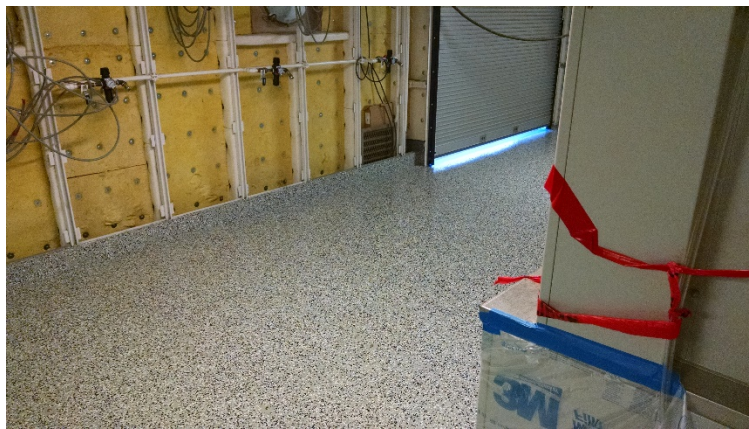
Wet Lab deck

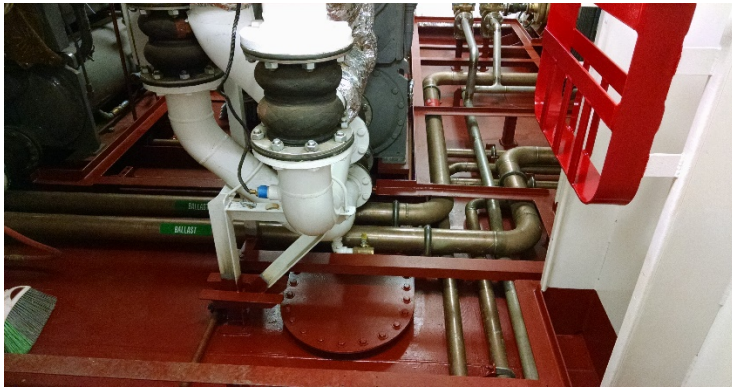
AUX Machinery Room bilge cleaned and paint touched up.

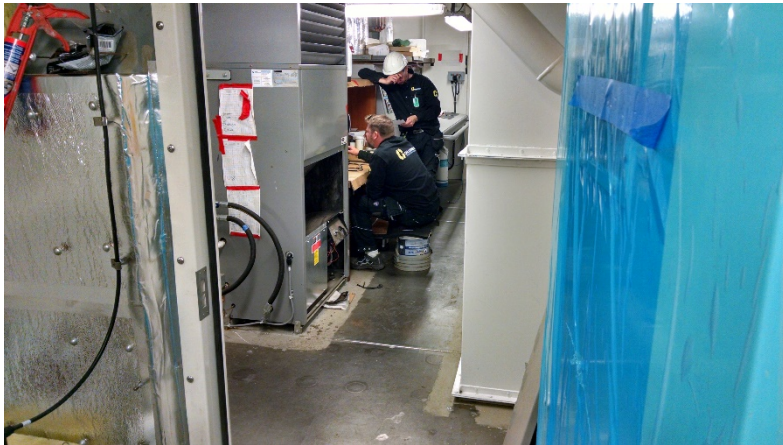
Callenberg continues work balancing HVAC system.

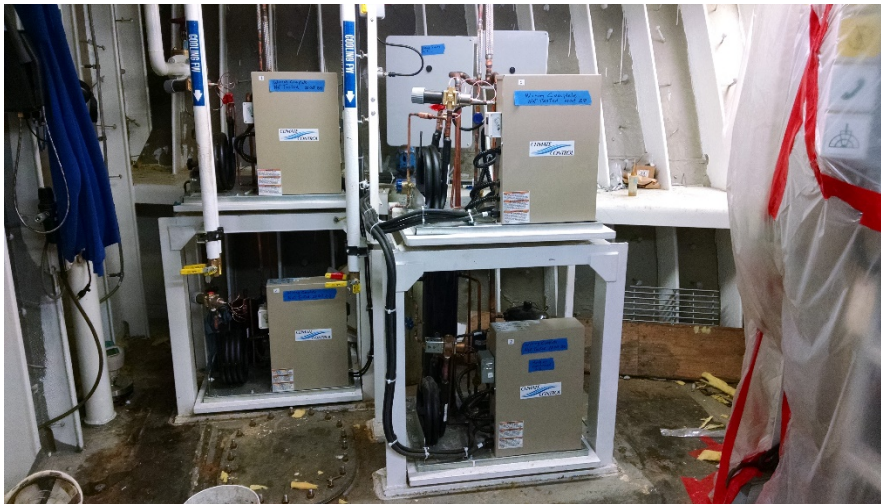
Refrigeration Contractor aboard pressure testing piping between ships refer plants and compressors in BT space. Science Refer piping pressure testing scheduled for tomorrow.

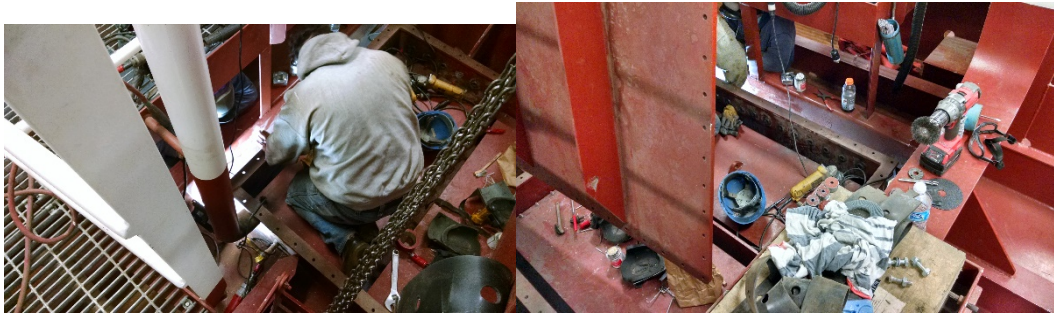
Stuffing tubes being welded in on 3.5 khz sub-bottom profiler. Cable penetrations in side of enclosure will allow lifting the lid off to service individual transducers.

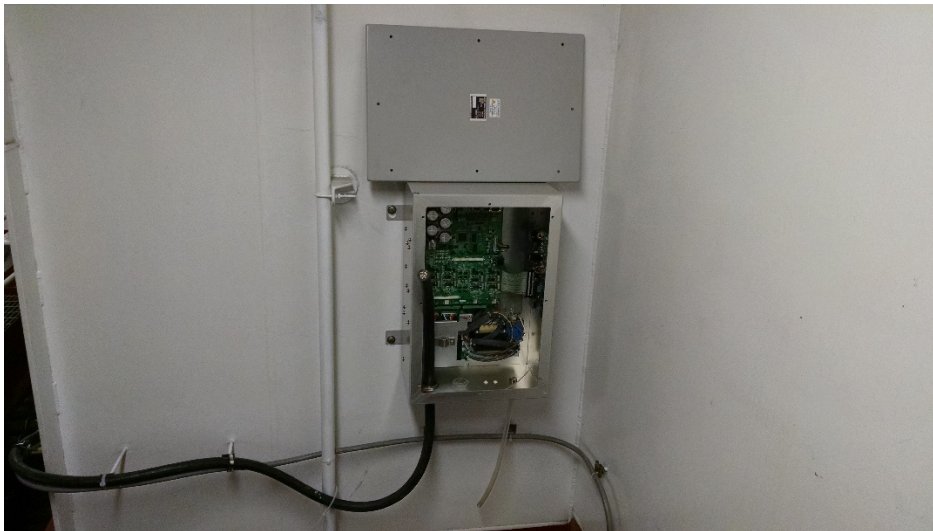
Upgraded cable installed to connection box in transducer room for bridge speed log. Replacing this cable seemed to remedy speed log issues on Armstrong.

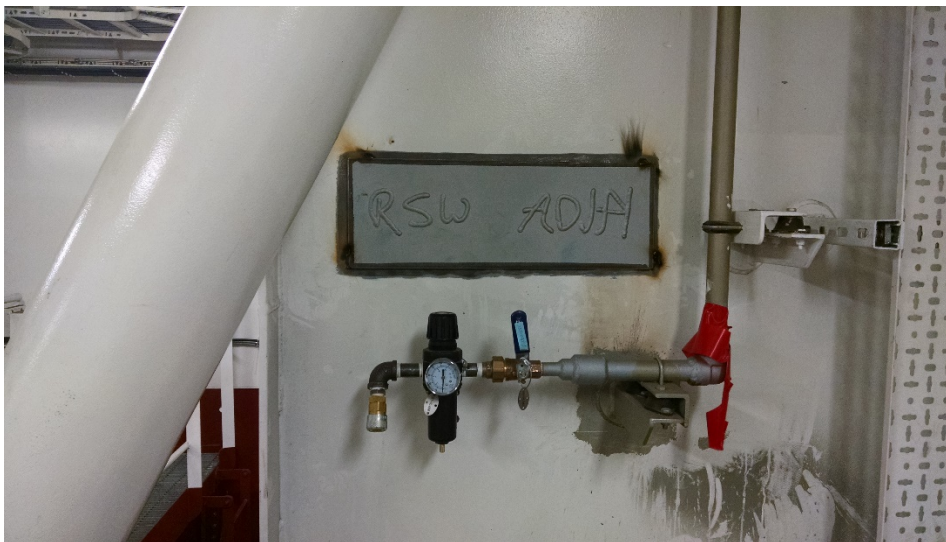
Signature Plaque installed on main vertical frame in Transducer room.

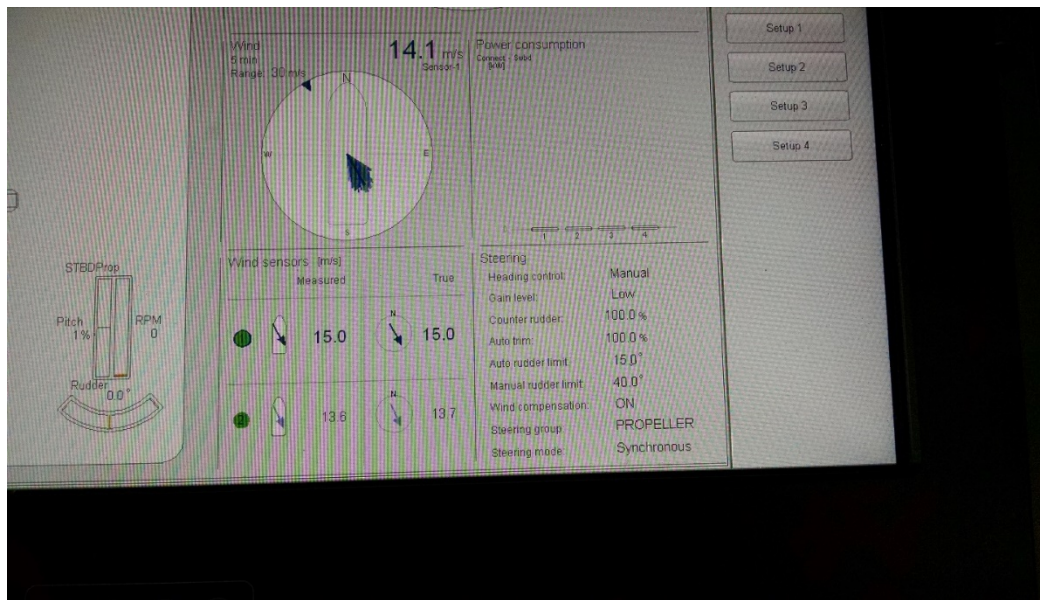
WTD .

There is a pull down menu on the DP with values for "Steering". It would seem that these parameters should be user adjustable. If these factors can be adjusted, then potentially at least, rudder action could be reduced by operator as necessary. Once I see the Kongsberg tech will ask.

Still think addition of coolers for the rudder hydraulics should be investigated.
